Plextor Firmware Updates

The recent Plextor readers and writers have flash memory for their firmware and the updates can be downloaded from [Plextor's website](#).

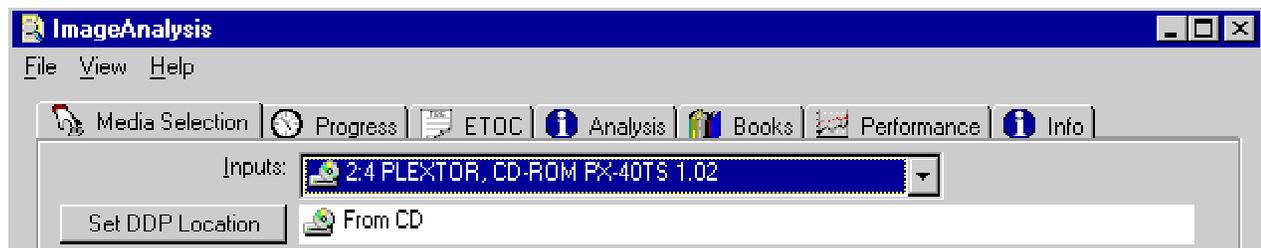
Using the EclipseSuite products, you can see the firmware version of the drive listed in the "Inputs:" field on the "Media Selection" tab. The last number on the line is the firmware revision. In this example, we have version 1.02. (For writers, you'll need to use ImageCopy and look at the "Outputs:" field for the firmware version).
